DOI FY 05 Aviation Mishaps

**5 Aircraft
Accidents**

**9 Incidents
with Potential**

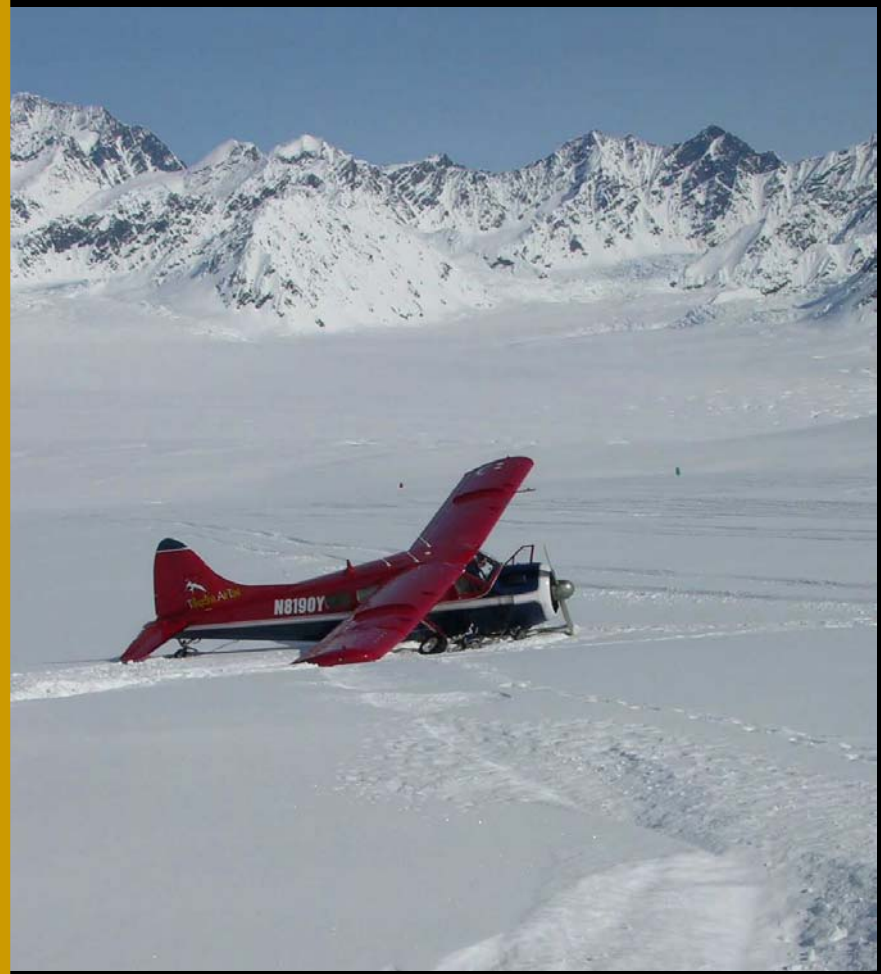
After landing on the Ruth Glacier, Denali National Park, the pilot taxied outside of the normal maneuver area to drop cargo in a convenient location.

While taxiing, the aircraft approached and attempted to clear a crevasse.

However, the aircraft sustained substantial damage while attempting to jump the crevasse.

Two NPS passengers received minor injuries.

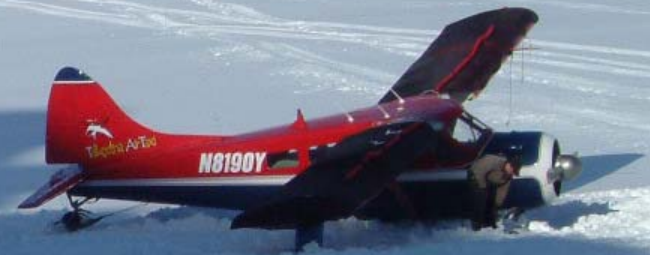
Nearly invisible
due to the slope

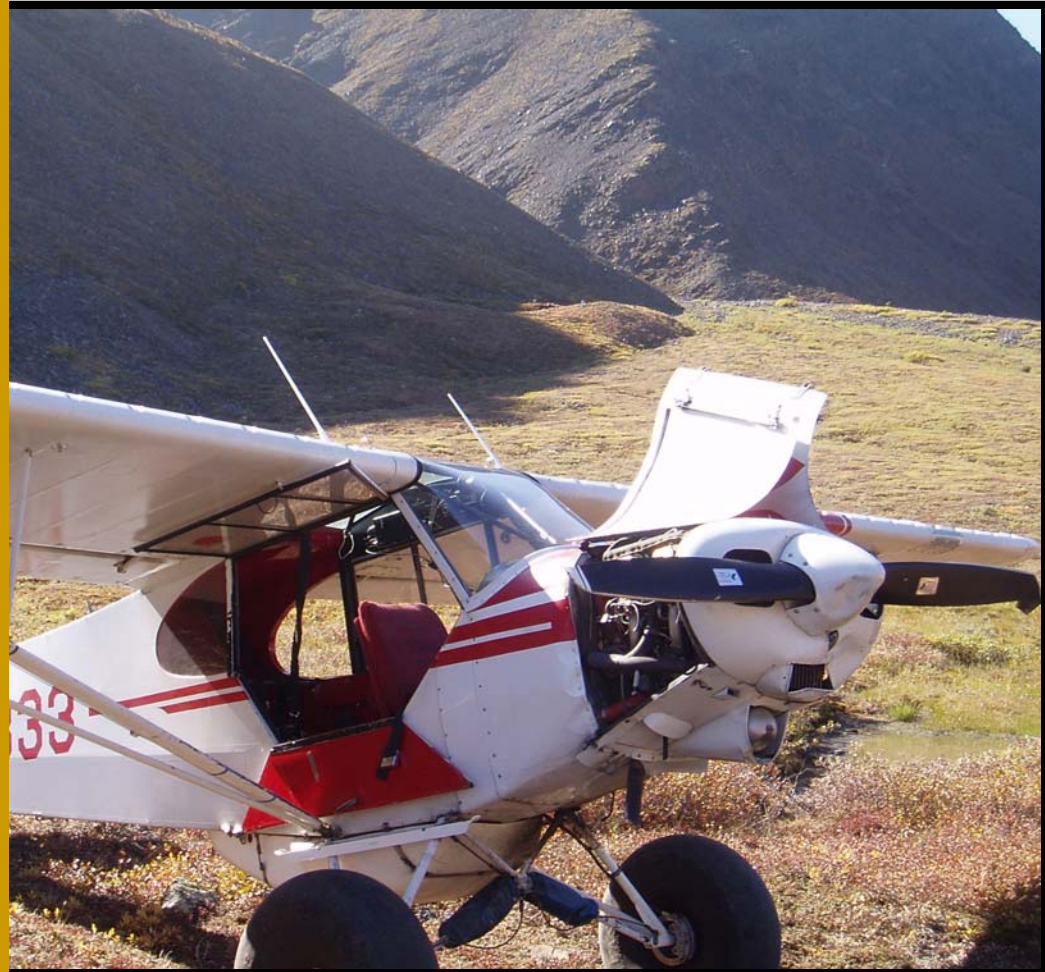
Engine deflected to the right
and damage to propeller blades

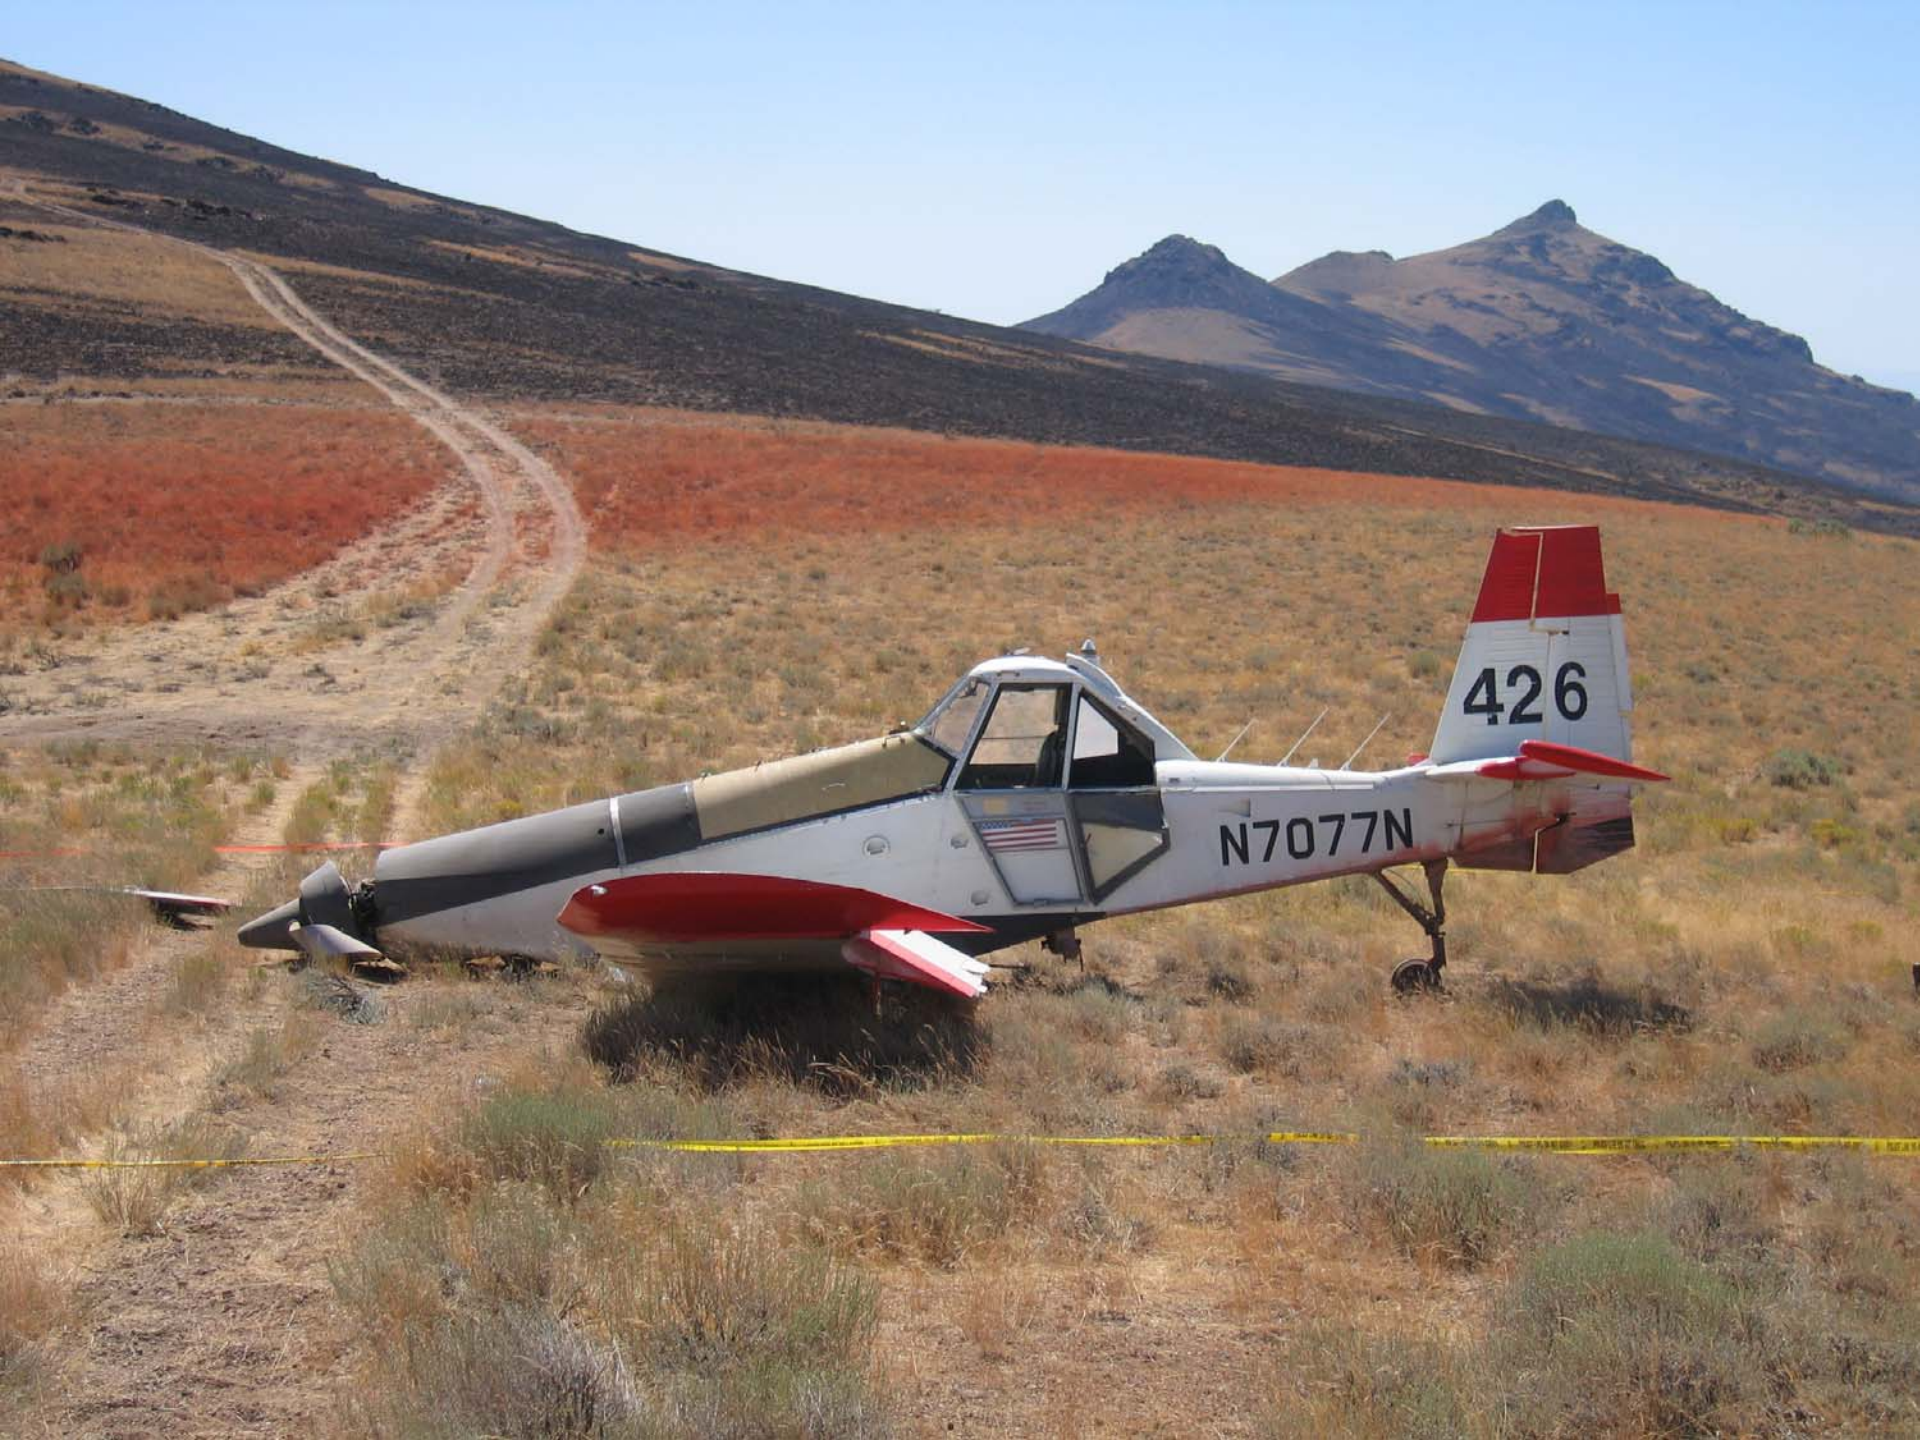
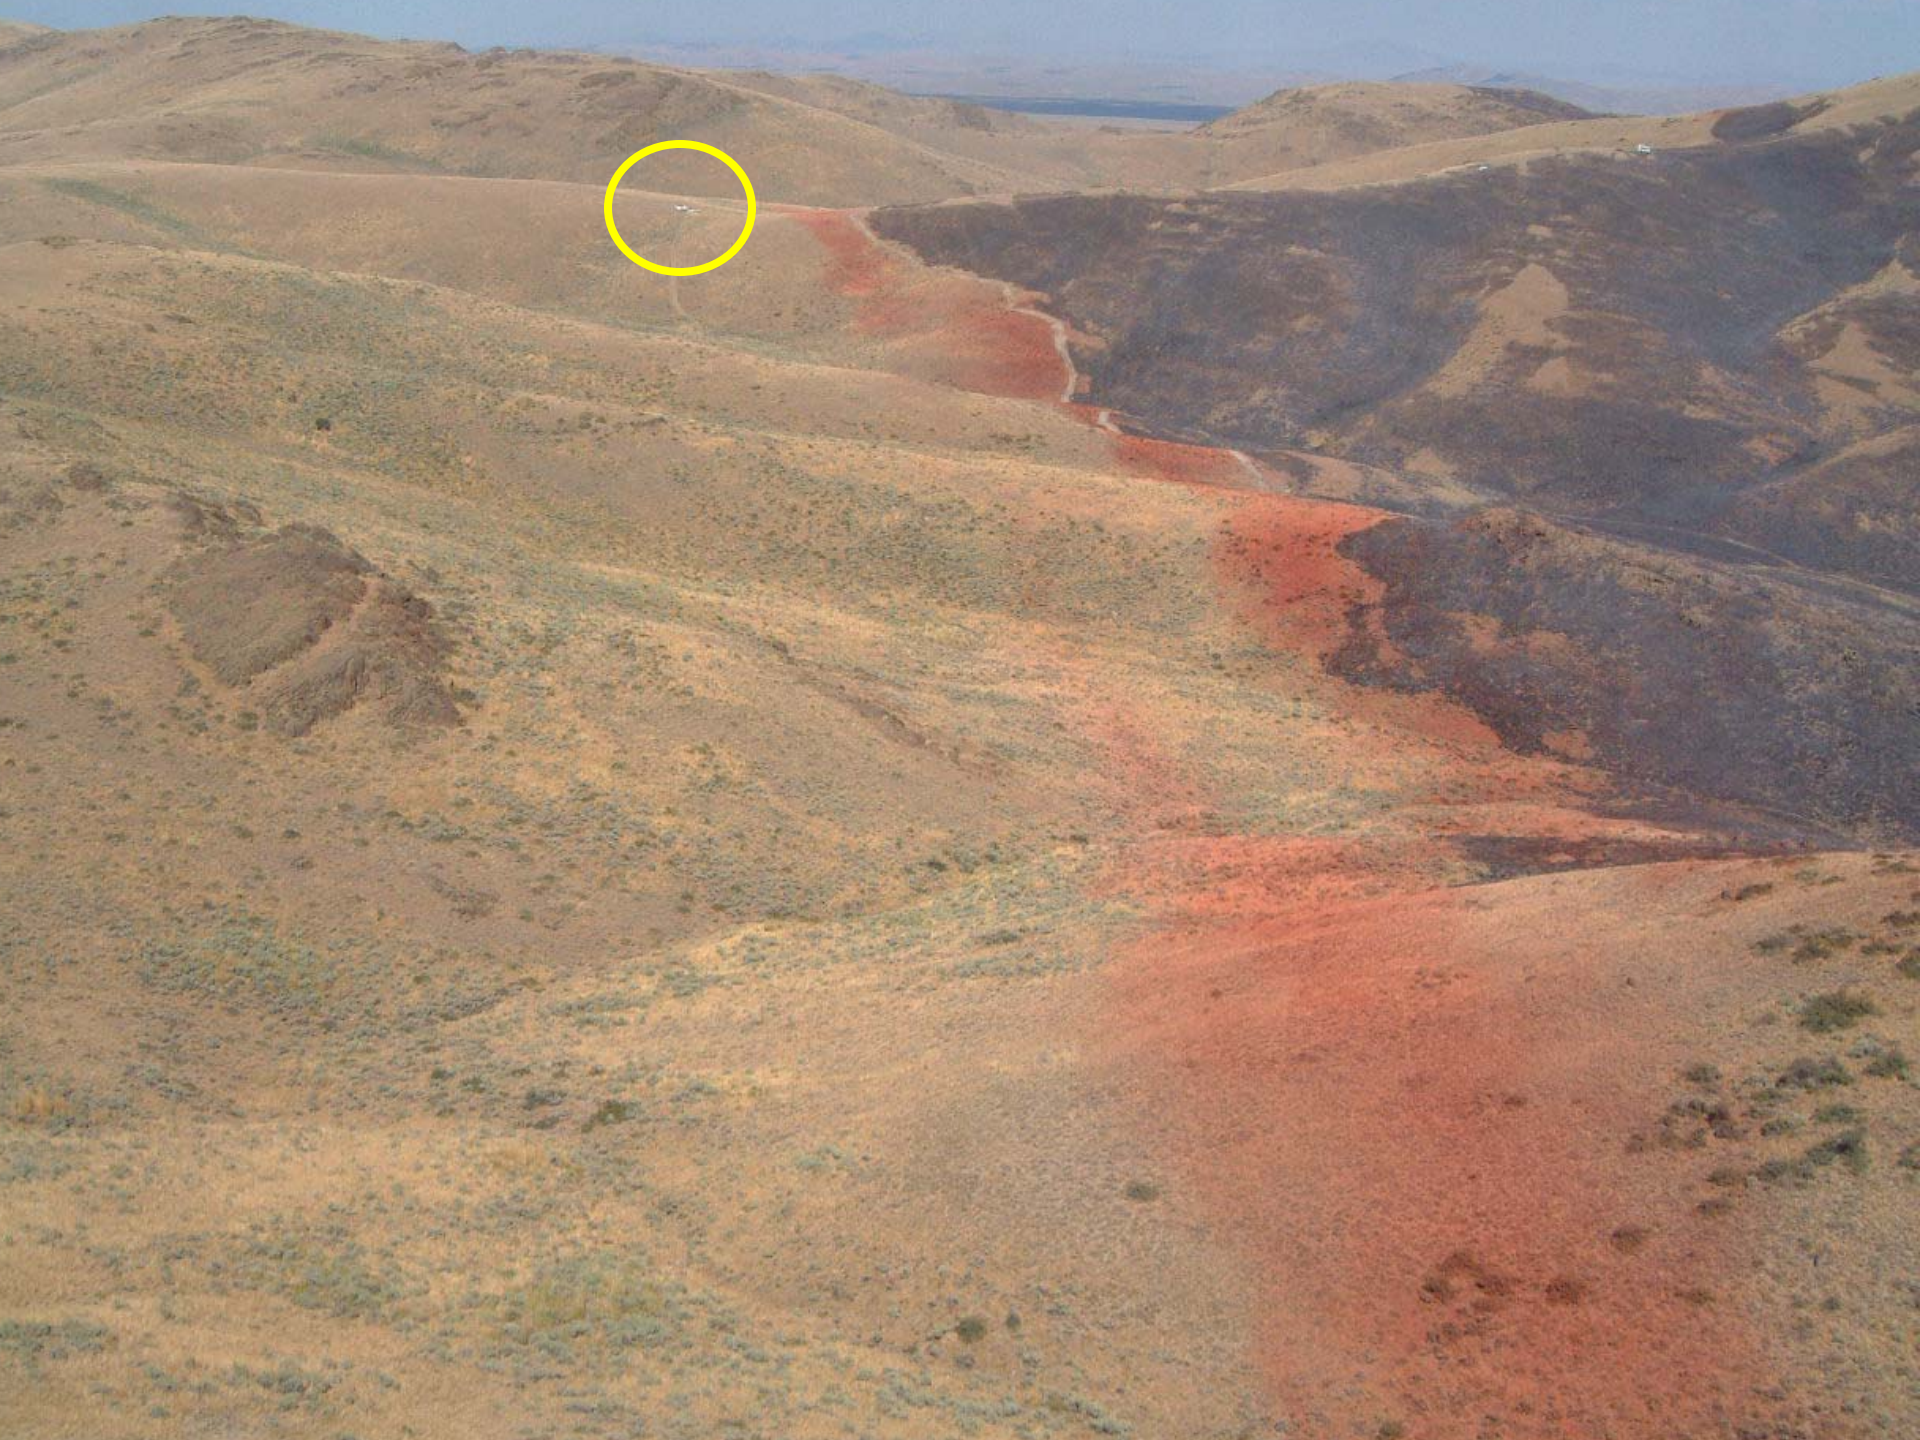
Point of initial impact

After performing a retardant drop under downhill and downwind conditions the aircraft was unable to establish an adequate rate-of-climb to prevent ground impact.

The pilot received minor injuries.

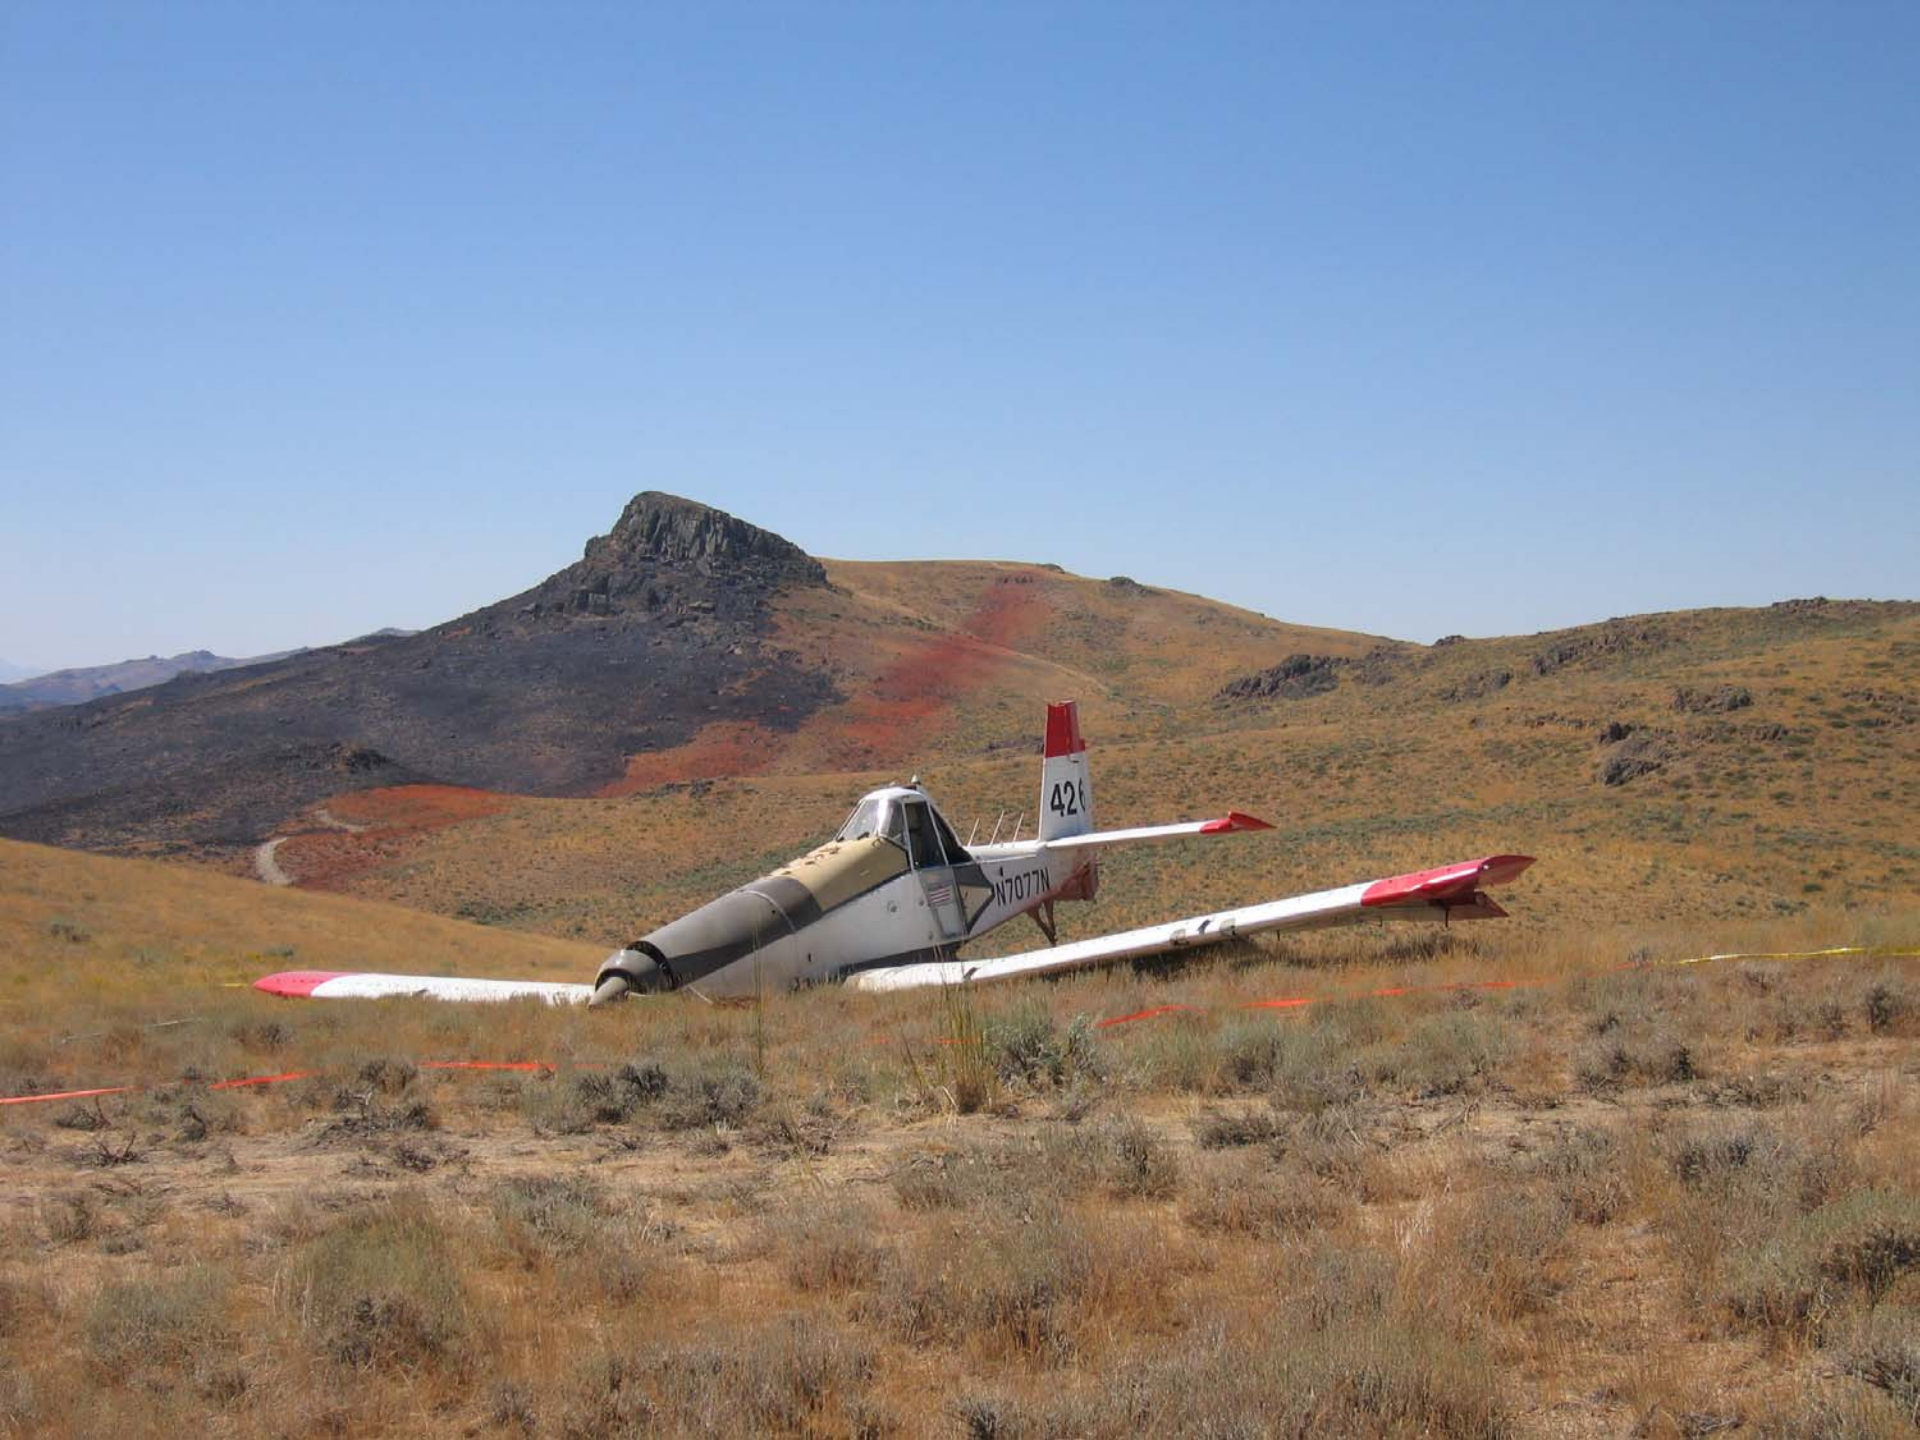
Heading 054°
